BIOIMPACT, INC.
P.O. BOX 132 KINGSHILL
ST. CROIX, U.S. VIRGIN ISLANDS 00851

Re: Great and Little St. James

Great St. James Wetland

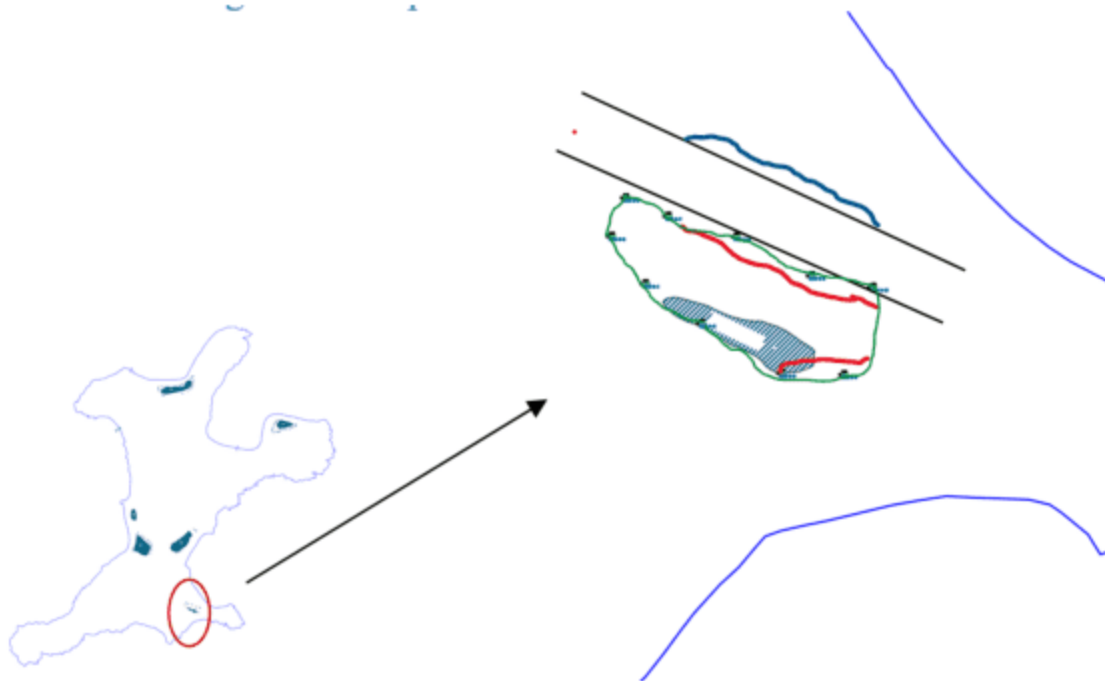
Areas of wetland Encroachment. The wetland is shown in green and the areas of wetland encroachment are shown in red and the area fill into the drainage into the wetland is shown in blue. The wetland jurisdiction was approved by Jose Cedeno during the application process for a previous development project on the island.

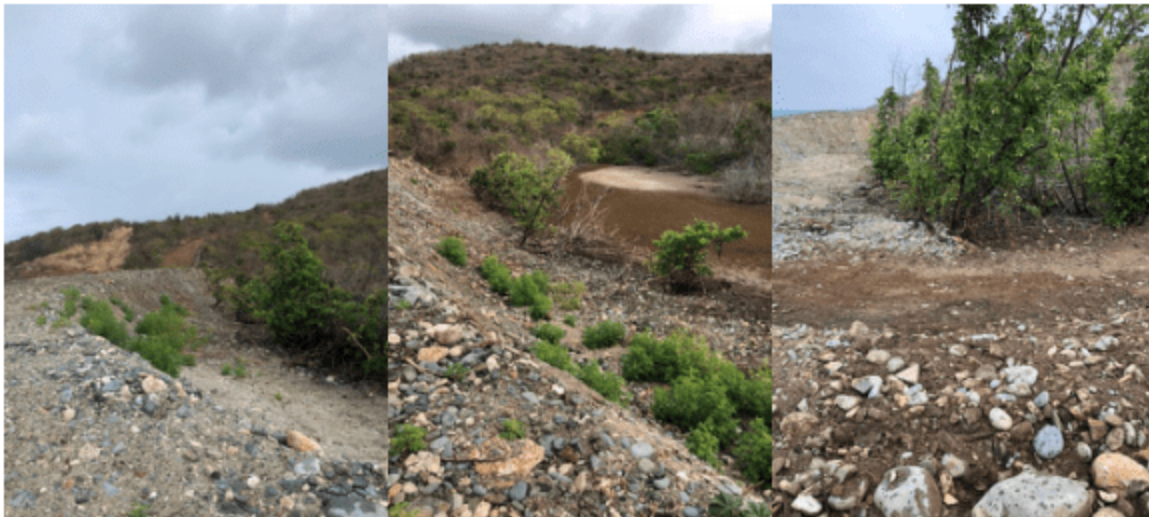
The fill material has been completely pulled out of the wetland and the ground restore to the proper elevation.

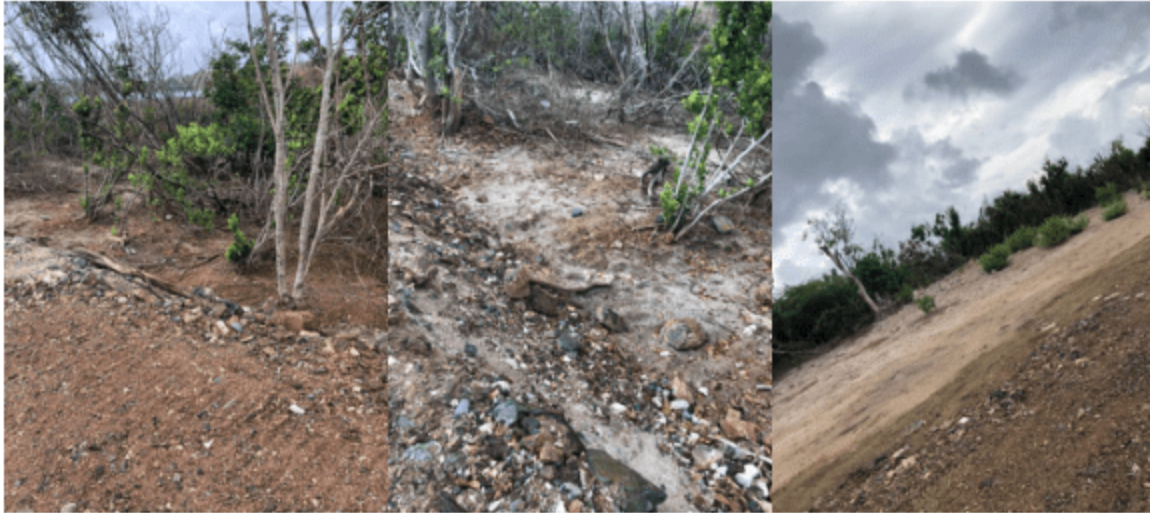
The fill has all been removed. The recovery of the mangroves and vegetation since the storm is evident in June of 2018.

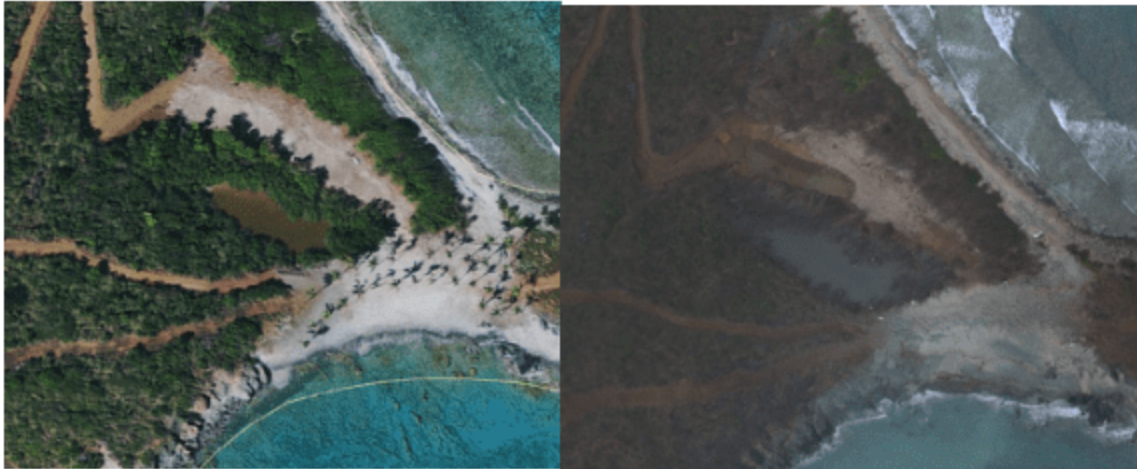
Before and after hurricanes Irma and Maria.

Now that the fill has been removed it no longer extends into the jurisdictional wetland.
